AMP BedStep ?

AMP PART # 75407-01A

Chevy Silverado / GMC Sierra

IM75407 rev 01.02.19

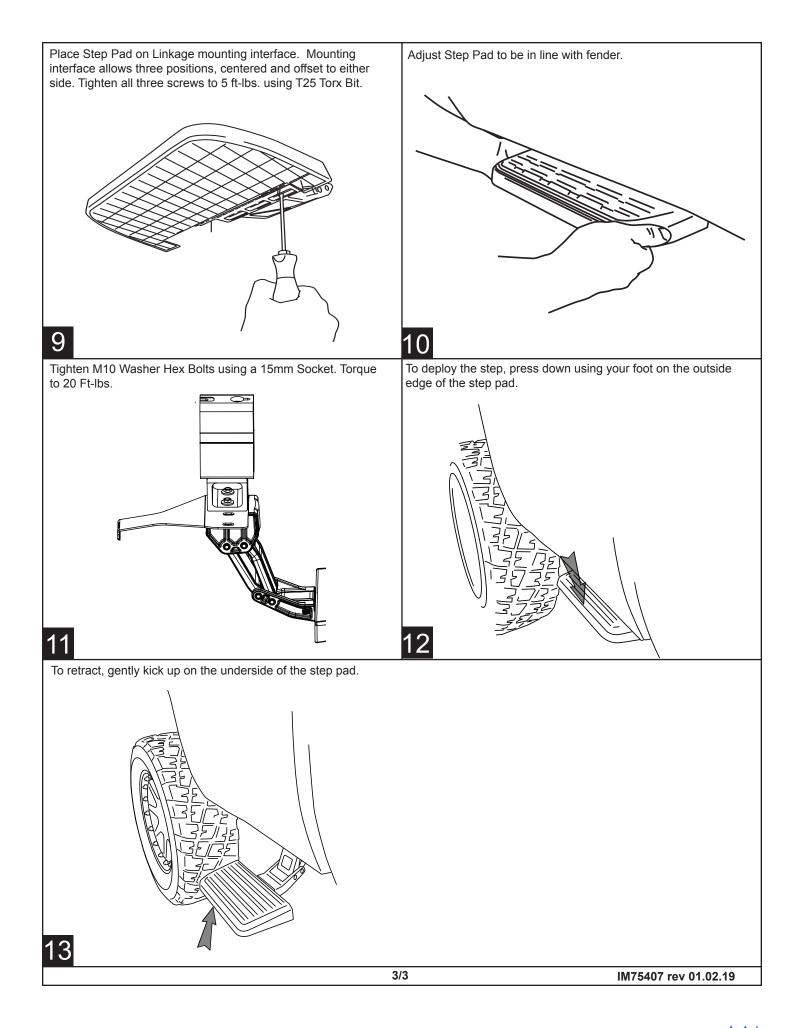
The AMP Research BedStep2[™] is foot operated and deploys and retracts with a nudge of your foot. To deploy, press down using your foot, on the outside edge of the step pad. Maximum load capacityof the deployed step pad is 300 lbs. Always use appropriate hand holds when stepping up to or down from your truck's cargo bed.

To retract, gently kick up on the underside of the step pad.
